MONTHLY SAFETY MEETING

Date: December 2018
Subject: TOW HOOK FAILURE ALERT!

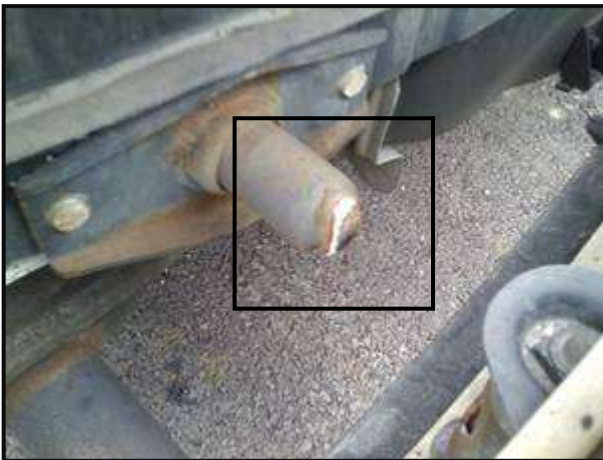
The photograph illustrated on the left is where the tow hook is fastened through the bumper. The tow hook is screwed into a sleeve which is welded to the chassis.

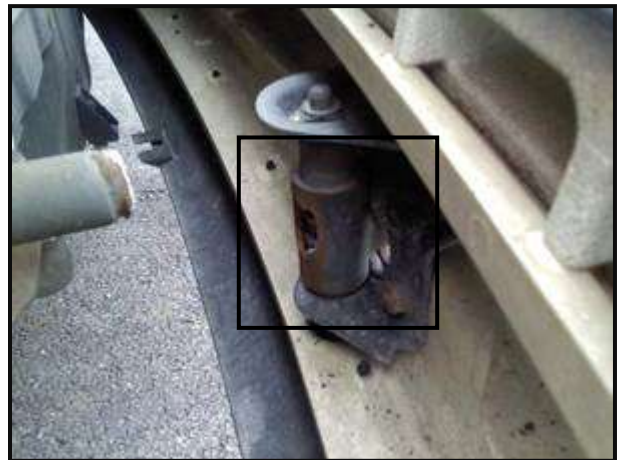
When the tow hook was screwed into position the sleeve broke away from the chassis while being winched onto the bed of the truck. As a result, the bumper cover was ripped off. After close examination it was determined that the weld did not have enough penetration which led to the failure. There were no other signs of metal fatigue etc.

An unfortunate situation occurred when a vehicle was being loaded on a rollback. The photographs illustrated below will serve as an example of what can happen. We are urging all of our members to use extreme caution when loading or unloading vehicles equipped with these tow hooks. It is further advisable to keep the surrounding area clear to prevent personal injury or damage.
